DEPARTMENT OF NATURAL RESOURCES
DIVISION OF OIL, GAS AND MINING

RE: Site Inspection, Miracle Rock Mining and Research (Rockland Corporation), Body Toddy Mine, S/015/040, Emery County, Utah

Date of Inspection: July 29, 1997

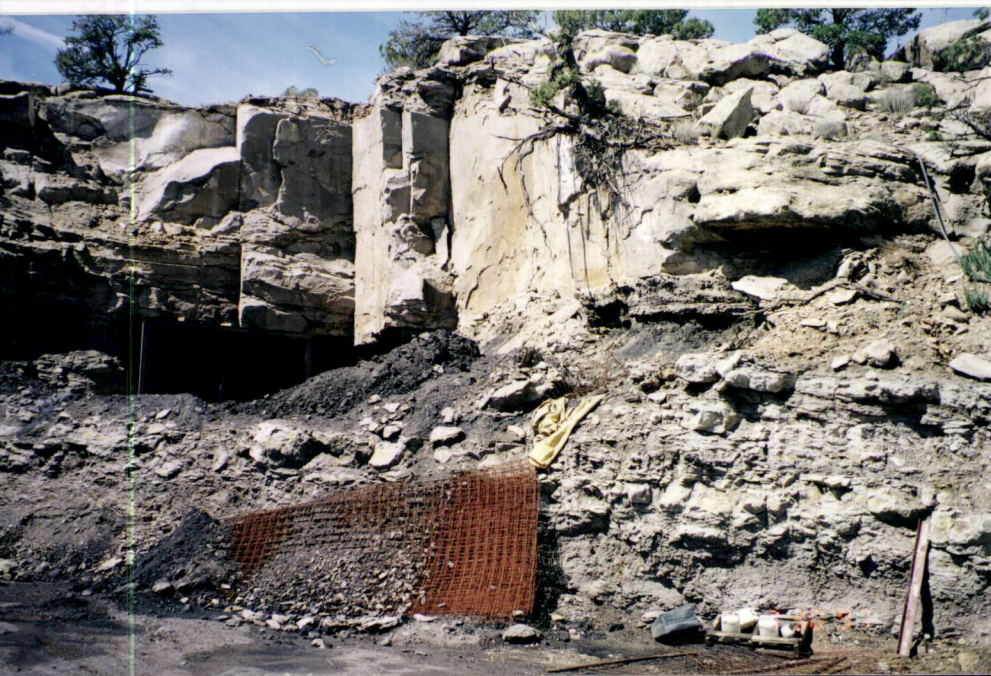
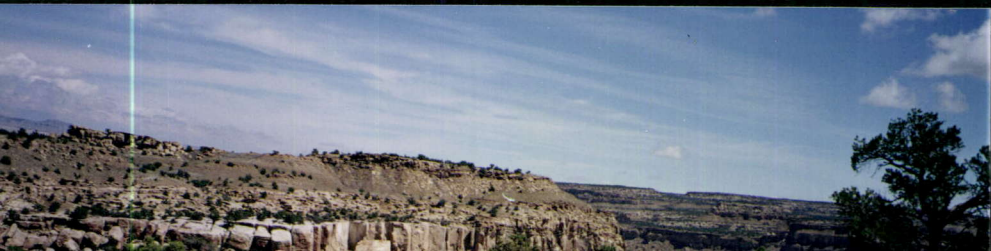
No. 125002 21+01 01000-1201 950

At the mine site we first visited the end of the site where a new portal is planned. Here in the new portal area, topsoil has been salvaged from around the rim of the ledge above the face where the portal is planned. Soils and vegetation have been scalped back from the rim and stockpiled for use in final reclamation. Photographs were taken of this area.
